Re: RED FLAG INVESTIGATION
DES 1600828, State Project
Bridge Project
SR 26 over Salamonie River, 0.78 miles East of US 27
Jay County, Indiana

WATERS OF THE U.S. DETERMINATION REPORT
S.R. 26 over Salamonie River
Bridge Replacement
Wayne Township, Jay County, Indiana
Des. No. 1600828
Prepared By: Cory Shumate, Metric Environmental, LLC
April 2, 2020

HISTORIC BRIDGE ALTERNATIVES ANALYSIS

026-38-03430 A
SR 26 over Salamonie River
Alternative Analysis Report – Photo Pages

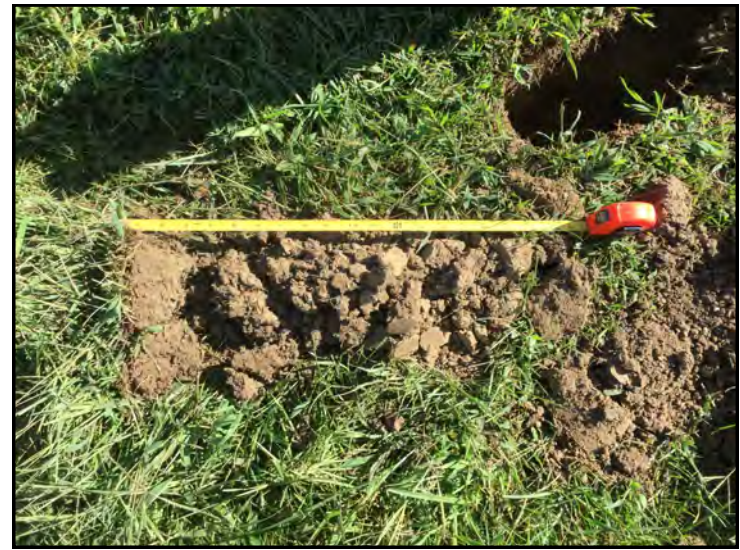
10. View of SP-B2, Wetland B upland, soil profile.

SP-B2 was located at the top of a hillslope north of Wetland B. The dominant vegetation at this sampling point was red fescue (*Festuca rubra*, FACU) and red clover (*Trifolium pratense*, FACU) in the herb stratum. This did not meet any of the hydrophytic vegetation indicators. To a depth of 20 in., the soil in the test pit was a silty clay loam. From 0 to 20 in., the soil exhibited mixed matrix colors of 10YR 5/1 (50 percent) and 10YR 5/2 (50 percent). This did not meet any of the hydric soil indicators. No primary or secondary indicators of wetland hydrology were observed. Since none of the three required wetland criteria were met, this area did not qualify as a wetland.

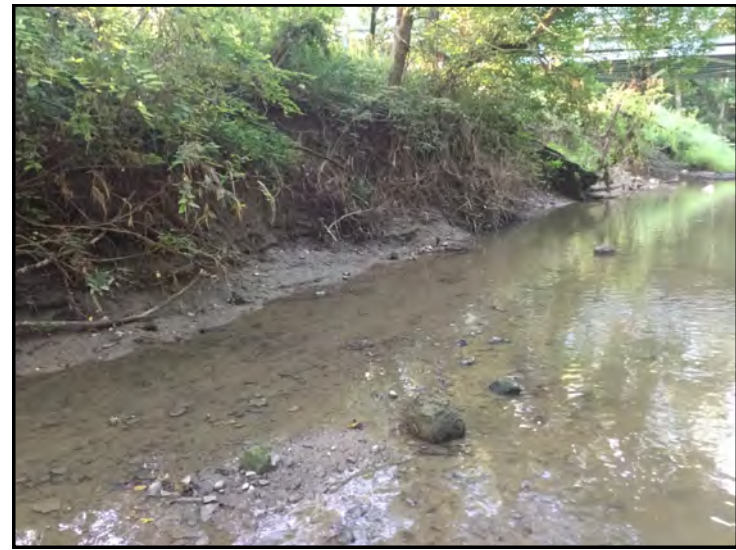
26. View of eastern bank of Salamonie River and structure to be replaced (Bridge No. 026-38-03430 A/NIBI No. 007040) from northern PSL, looking southeast.

The proposed project (Des. No. 1600828) includes replacement of the existing bridge (Bridge No. 026-38-03430 A/NIBI No. 007040), which carries S.R. 26 over Salamonie River in Wayne Township, Jay County, Indiana. The existing structure is a 150 ft. long span with a 28 ft. clear roadway width curb-to-curb. The proposed improvements include installation of a two-lane bridge that is a 3-span structure with a 30-ft. clear roadway width, subject to change upon further project design.

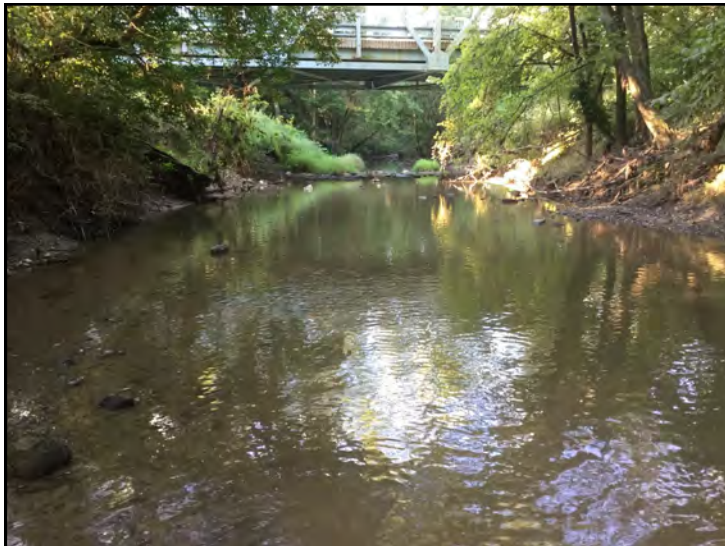
27. View of Salamonie River and structure to be replaced (Bridge No. 026-38-03430 A/NIBI No. 007040) from northern PSL, looking southwest (downstream).

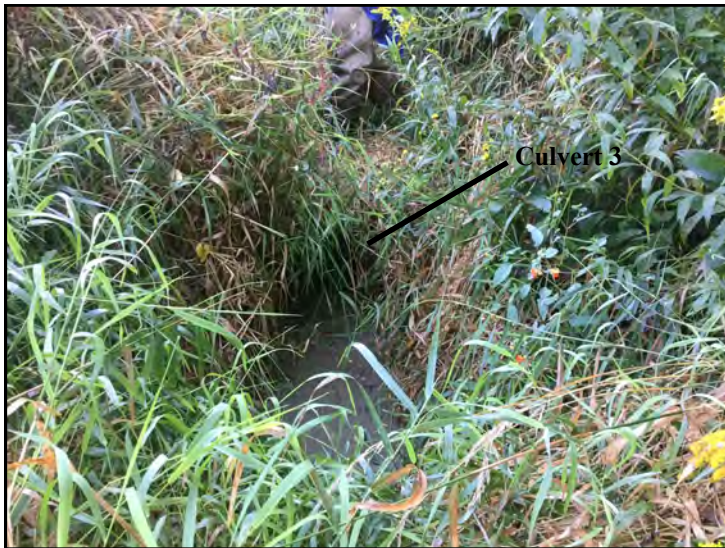
65. View of Culvert 3 outlet, looking east.

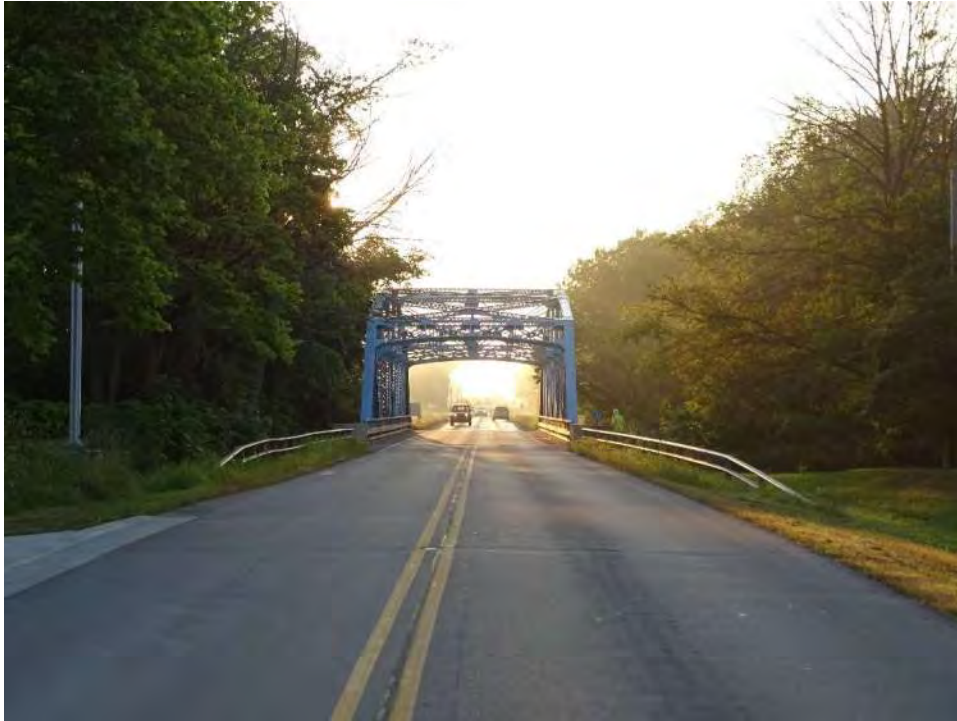
Photo 1: West Approach Looking East

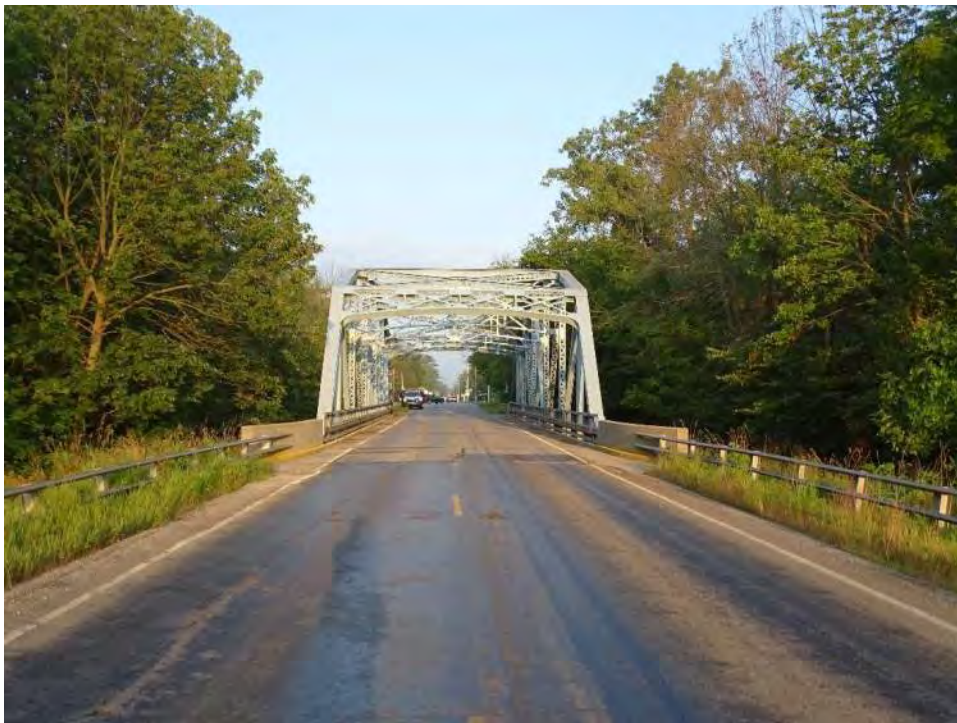
Photo 2: East Approach Looking West

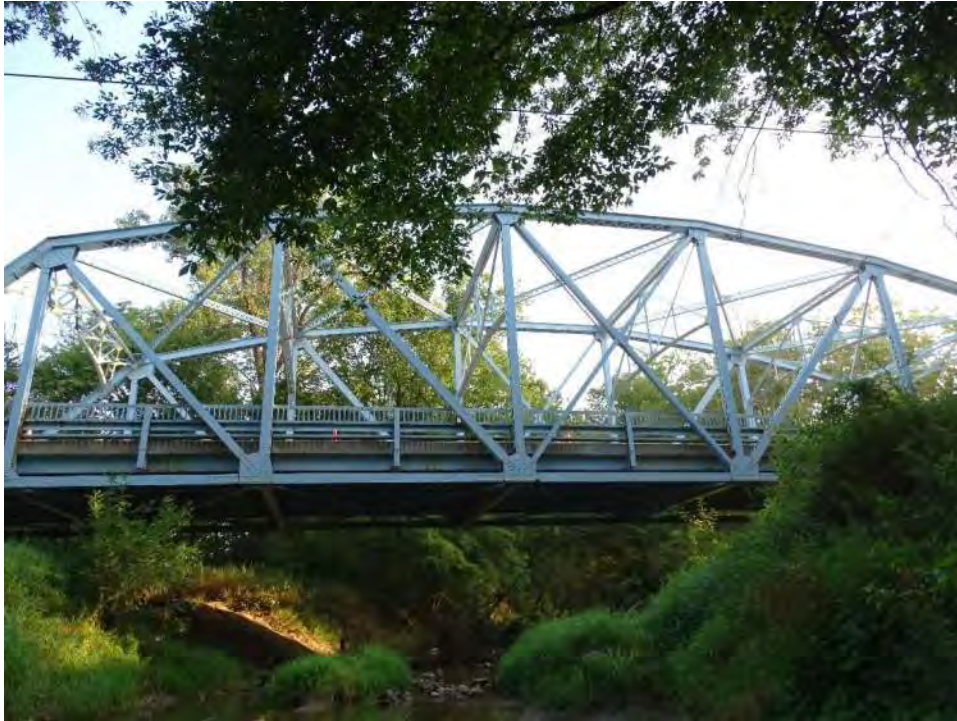
Photo 3: South Face Looking North

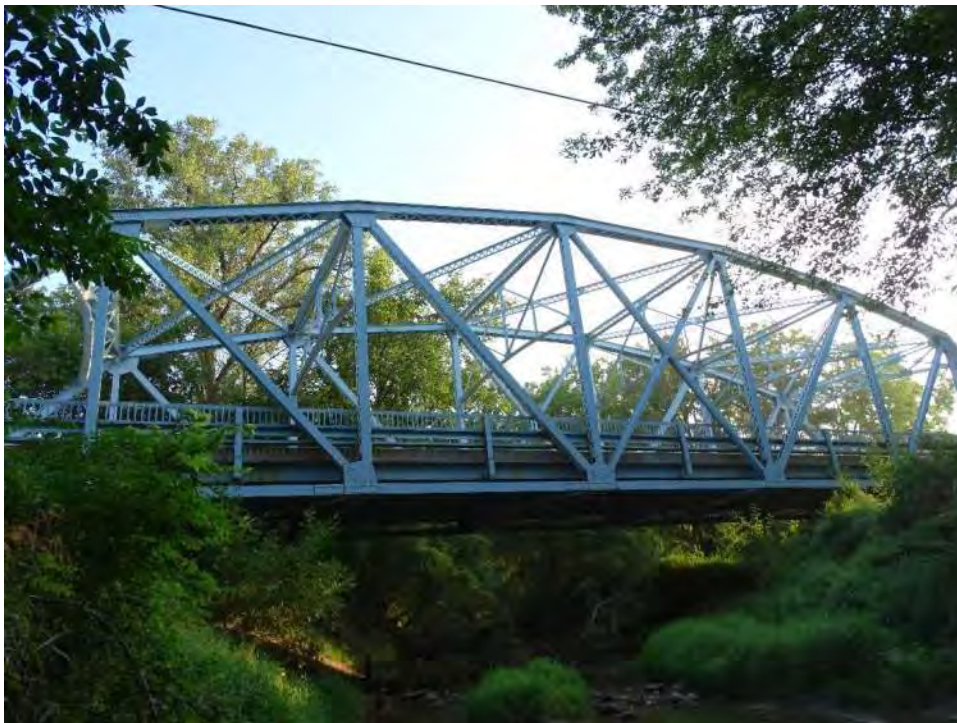
Photo 4: North Face Looking South

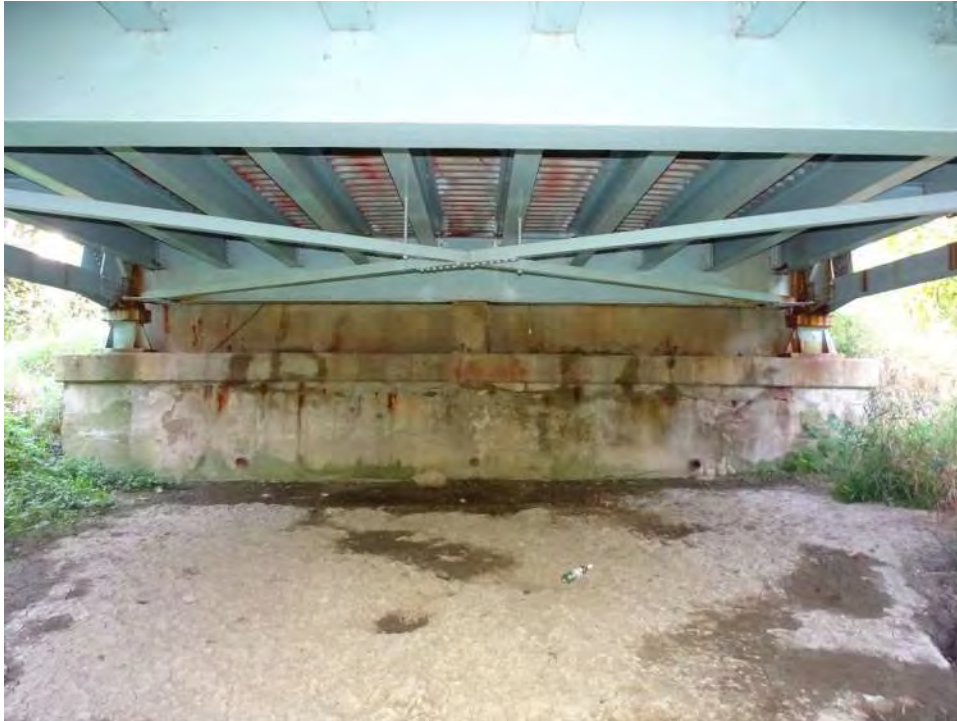
Photo 5: Looking West at Abutment 1

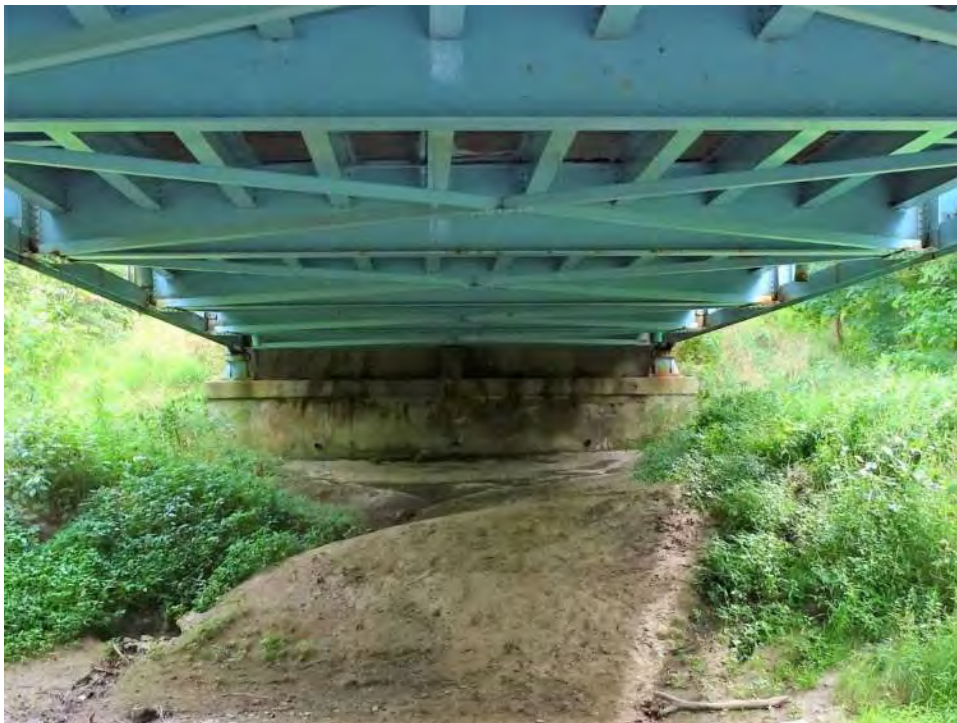
Photo 6: Looking East at Abutment 2

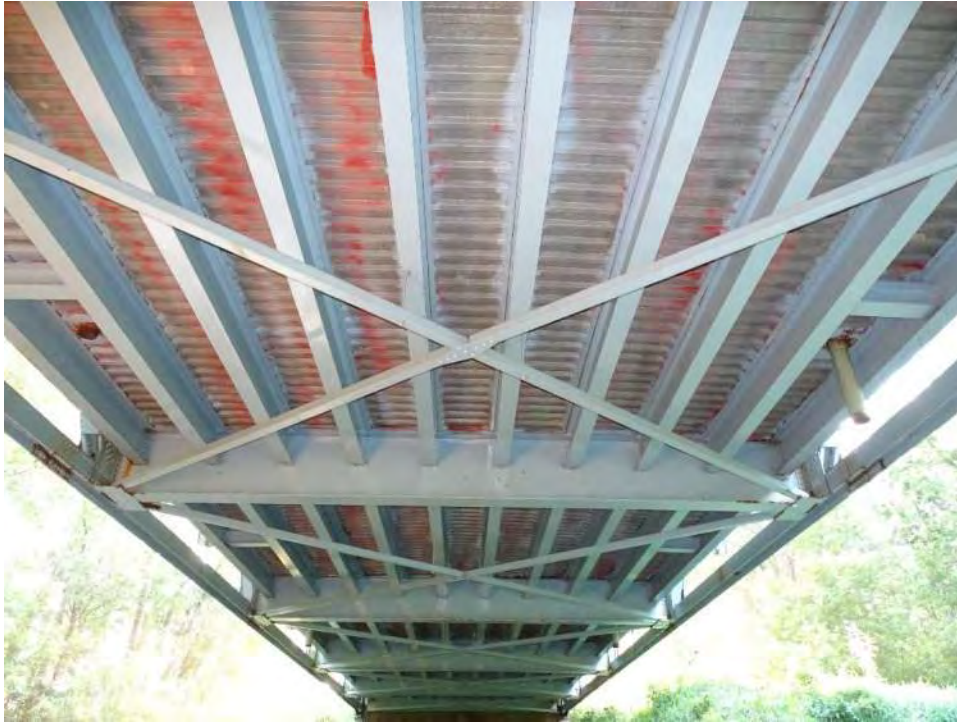
Photo 7: Floor System

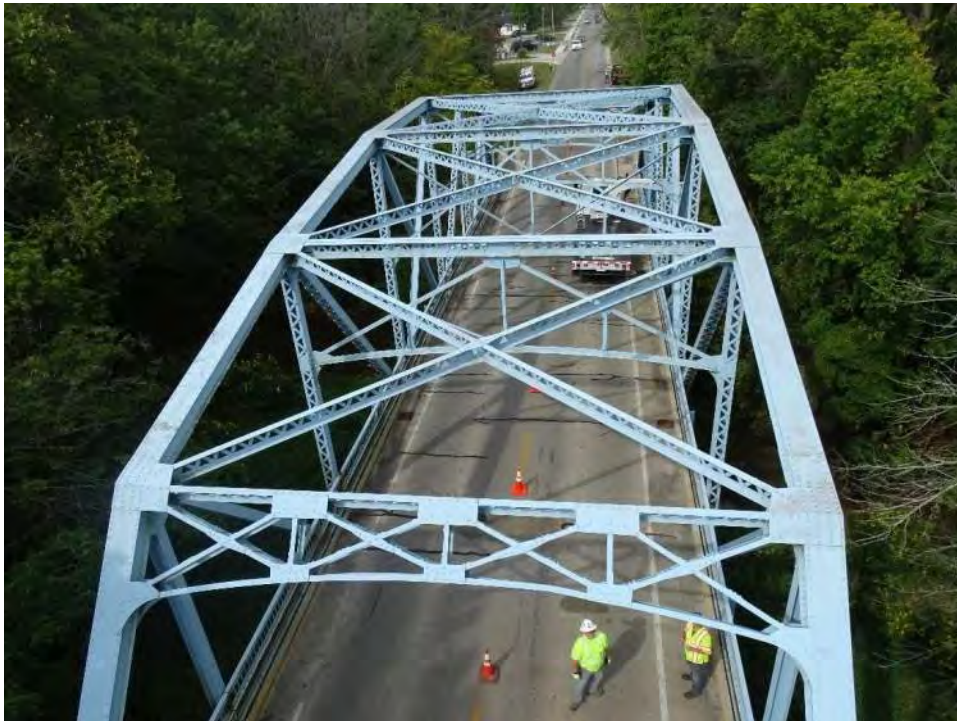
Photo 8: Aerial View of Truss
